# NORTH ORBIT

## ACOUSTIC LABORATORIES

REPORT NUMBER	NOAL 25-03004
TEST METHOD	ASTM C423-23e1: <i>Standard Test Method for Sound Absorption and Sound Absorption Coefficients by the Reverberation Room Method</i>
TEST SPONSOR	Cutting Edge Deck LLC, 12543 Unison Road, Houston, TX 77044
ISSUED TO	Cutting Edge Deck LLC, 12543 Unison Road, Houston, TX 77044
TEST SPECIMEN	1.5BA Acoustic Roof Deck
RESULT SUMMARY	NRC 0.60 SAA 0.59
TEST DATE	March 5, 2025
REPORT DATE	March 17, 2025
TEST SITE	North Orbit Acoustic Laboratory Facility, 917 Rice Street, St. Paul, MN 55117
TECHNICIAN	D. Berg

Mounting	Type A Mounting - Test specimen laid directly against the test surface.
Identification	1.5BA Acoustic Roof Deck
Description	1.5BA Acoustic Roof Deck mounted over 2" Polyiso board with glass reinforced facing - plain insulation in flutes

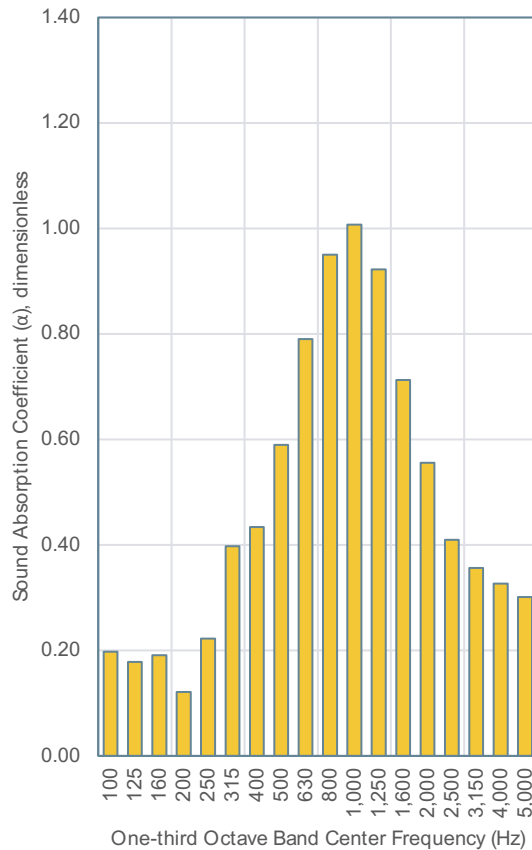
**NRC 0.60; SAA 0.59**

FREQUENCY Hz	ABSORPTION COEFFICIENT $\alpha$ / dimensionless
100	0.20
125	0.18
160	0.19
200	0.12
250	0.22
315	0.40
400	0.43
500	0.59
630	0.79
800	0.95
1,000	1.01
1,250	0.92
1,600	0.71
2,000	0.56
2,500	0.41
3,150	0.36
4,000	0.33
5,000	0.30

FREQUENCY BAND	TOTAL ABSORPTION AREA		ABSORPTION COEFFICIENTS
Hz	m <sup>2</sup>	SF	$\alpha$ / dimensionless
100	1.35	14.5	0.20
125	1.21	13.1	0.18
160	1.30	14.0	0.19
200	0.83	8.9	0.12
250	1.51	16.3	0.22
315	2.71	29.2	0.40
400	2.96	31.8	0.43
500	4.02	43.3	0.59
630	5.38	58.0	0.79
800	6.48	69.7	0.95
1,000	6.86	73.9	1.01
1,250	6.29	67.7	0.92
1,600	4.86	52.3	0.71
2,000	3.79	40.8	0.56
2,500	2.79	30.0	0.41
3,150	2.43	26.1	0.36
4,000	2.23	24.0	0.33
5,000	2.05	22.1	0.30
SAA			0.59
NRC			0.60

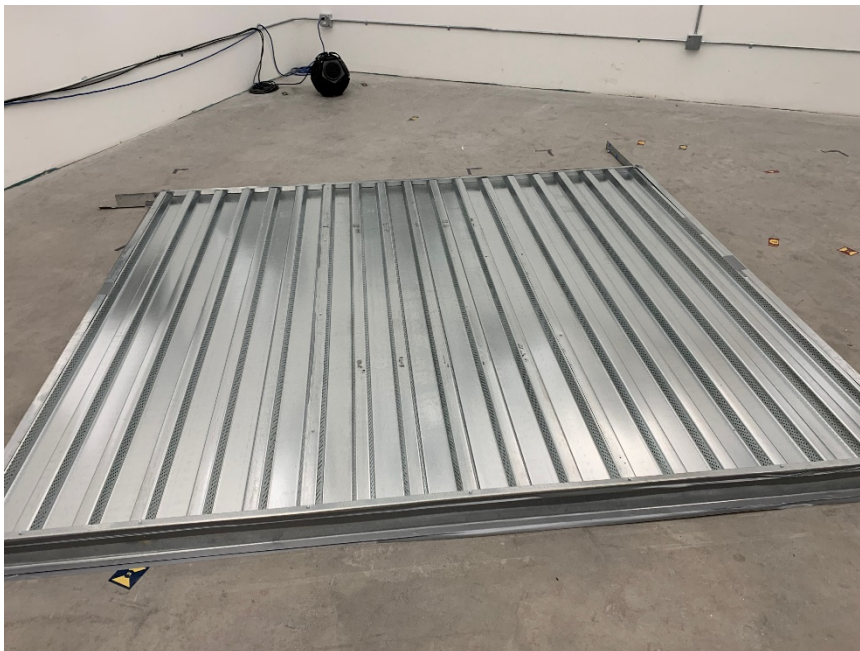
The test specimen was designated as a 1.5BA acoustic roof deck by the test sponsor. The deck was installed over 2" Polyiso board with glass reinforced facing and with 0.82 PCF. plain fiberglass insulation strips within the metal flutes. Three metal deck pieces were fastened together at the seam with four #10 x 1" S-12 screws and placed over the rigid fiberglass board. The exposed edge of the metal deck and fiberglass insulation was enclosed by four 20-gauge metal L angles that measured 1" x 2" and totaled 412.5" in length.

The specimen was installed according to Type A Mounting as specified in ASTM E795. Type A Mounting is the test specimen laid directly against the test surface, in this case, the bare concrete floor of the test chamber. The perimeter of the metal frame was sealed with 2" duct tape.

Mounting Condition	Type A Mount (ASTM E795)
Specimen Thickness	0.089 m [3.5"]
Coverage Dimensions	2.44 m x 2.79 m [96.0" x 110"]
Coverage Area	6.81 m <sup>2</sup> [73.3 SF]
Overall Mass	85.1 kg [188 lb]
